# Manhole Inspection Summary

Manhole # S41SS\_012MH

**Location** Address: **2525 CECIL AVE**

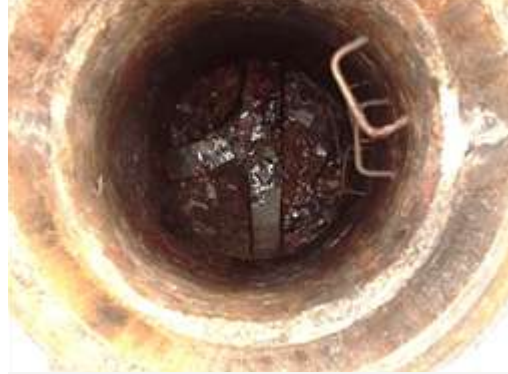
Top View

Corroded steps. Evidence of surcharge - Bench debris. Channel debris.

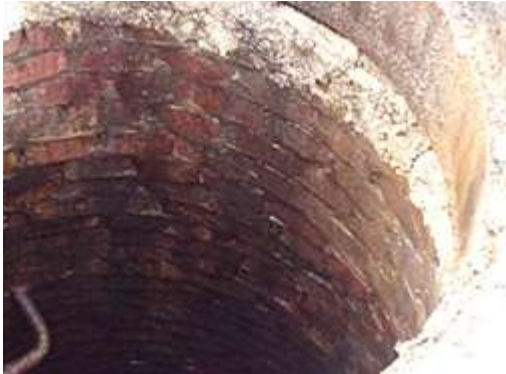
Defect

Frame leaks. Adjustment deterioration and infiltration. Corbel infiltration.

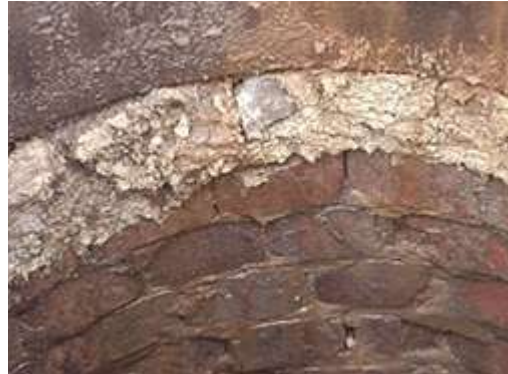
Defect

Frame leaks. Adjustment deterioration and infiltration.

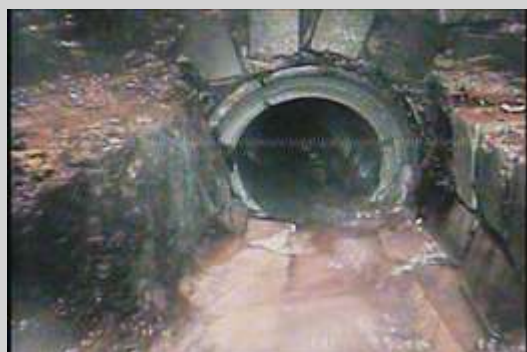
Pipe Out @ 12 O'Clock

Infiltration: **Evidence** Pipe Seal Cond: **Unknown**

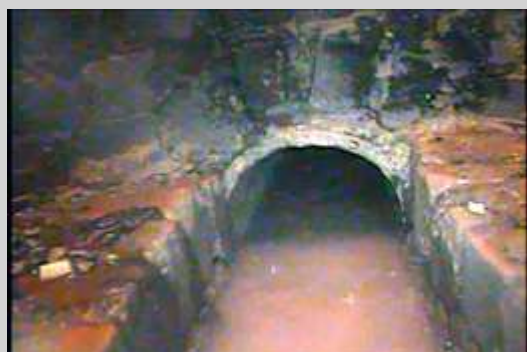
Pipe In @ 6 O'Clock

Channel deterioration.

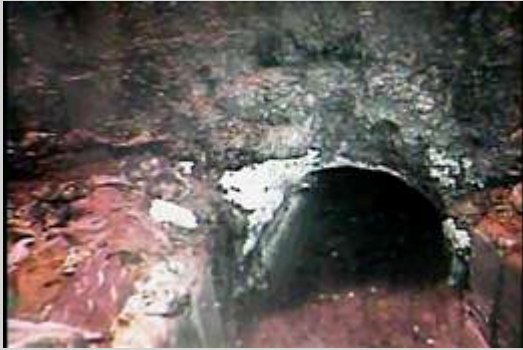
Pipe In @ 9 O'Clock

Deposits: ☐ None ☒ **Mud** ☐ Sludge ☒ **Debris** ☐ Grease

Silt Depth: **1** (in.)

Deposits Extent: **Light**
